Vulcan Testprogramm

Für Gewerbe und Industrie

4-Year Field Tested of Vulcan for the Cooling Tower at Supermal Karawaci (SMK)

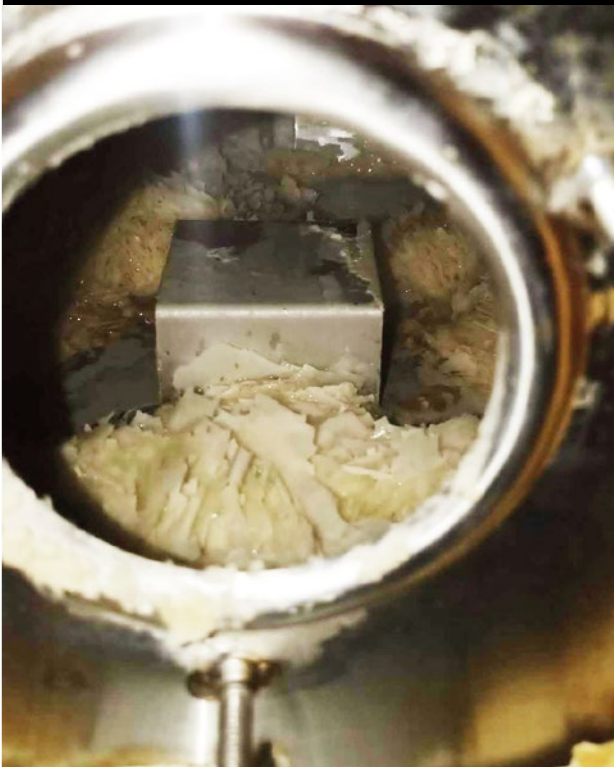
The untreated steamer

The scale was in flakes and could not be drained out of the steamer's drain hole. To test the effectiveness of the Vulcan system, no cleaning process was carried out before installing the Vulcan S10.

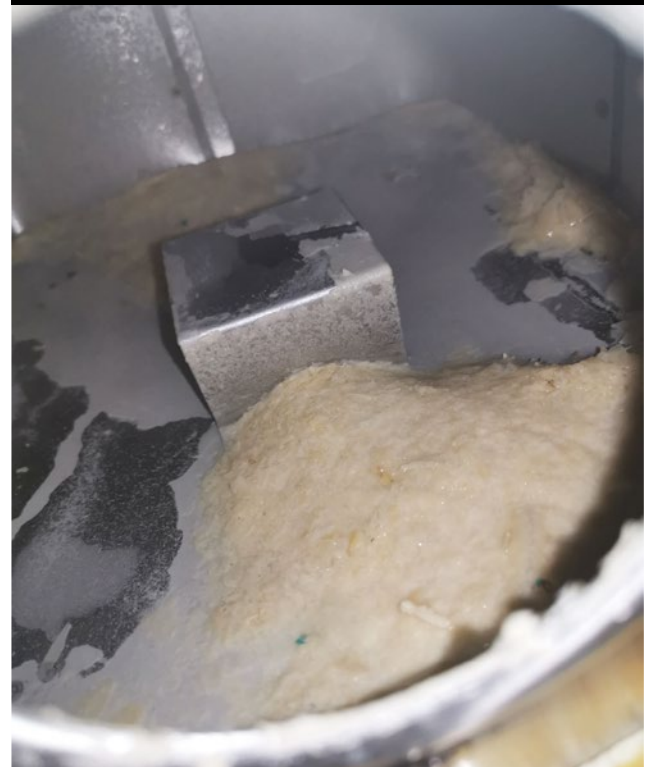
The steamer after using Vulcan S10 for 2 months

The scale has been completely turned into powder, so there is no need to open it for cleaning, just by operating the regular drainage function, it can keep the hot water tank clean and free of scale. Due to the good results, the cooperation will also be carried out in the hotel's hot water supply system and central air conditioning system.

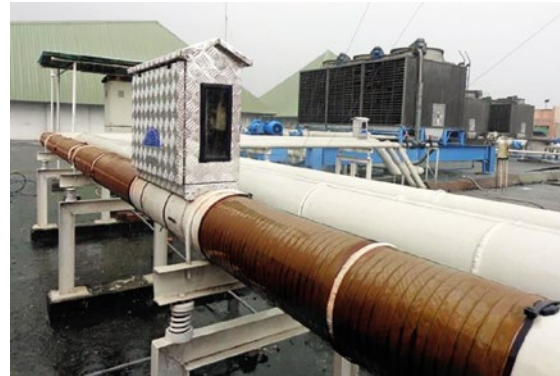
Vulcan S500 was located inside aluminum box and installed on a cooling tower main pipe.

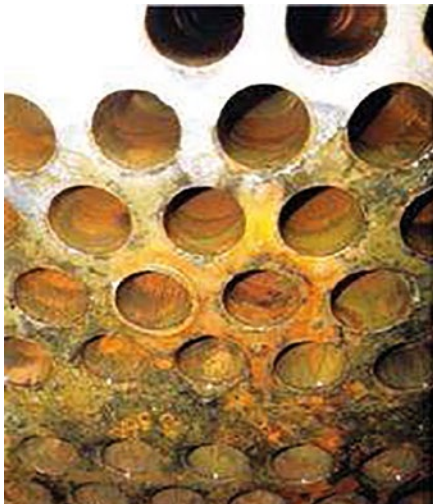
First Inspection: March 4, 2014.

The heat exchanger tube plates were removed to reveal the inside surface of the copper tubes. Since these tubes had recently been manually cleaned, virtually no scale was present, as is on this photo.

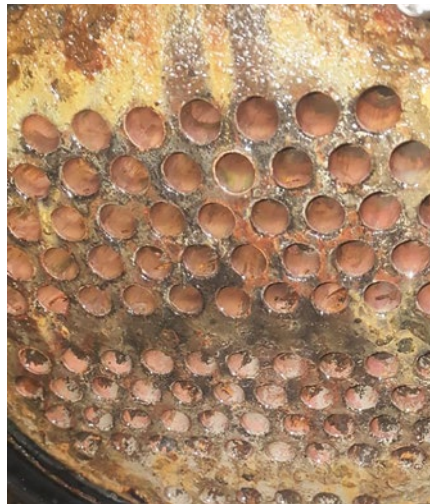
Last inspection: February 12, 2018 at the end of the 4-year trial

The inside surfaces of the copper tubes show zero additional scale formation after 4 years in the test period.

The photographs show that the refrigeration condenser tubes, from the beginning to the end of the trial period, were "as clean as new".

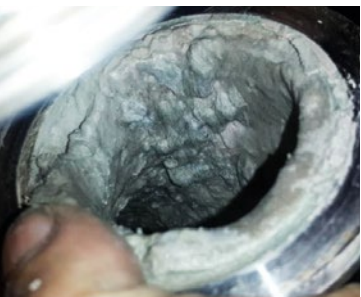
Before Vulcan installation: the pipe was full of scale deposits.

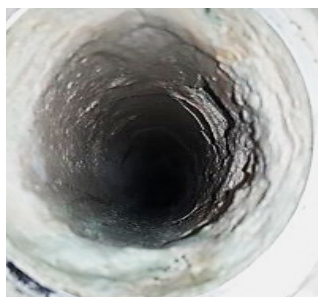
2 weeks after Vulcan was installed, scale had been softer and fallen out.

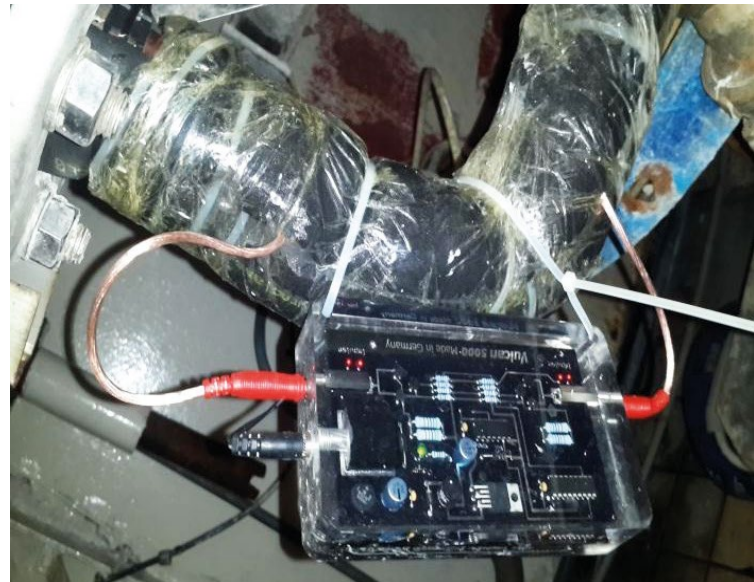
Vulcan 5000 was installed on the water inlet of the water recycling room.

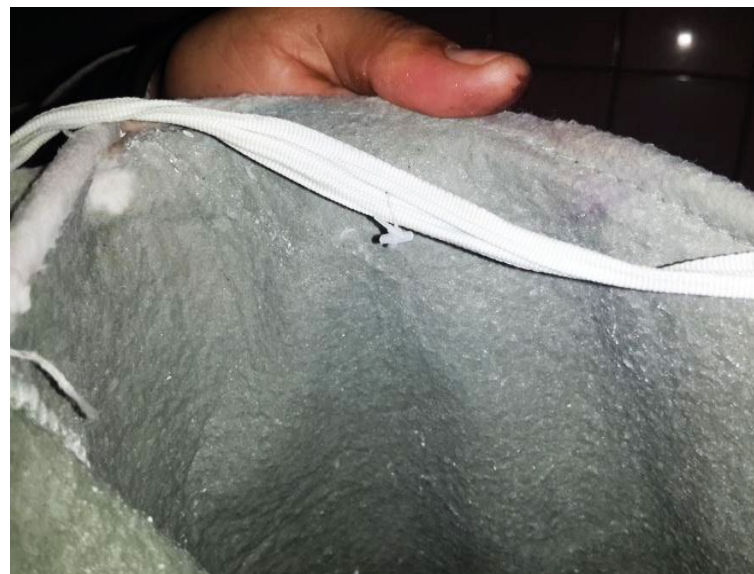
48 hours after Vulcan was installed, the filter still stays clean.

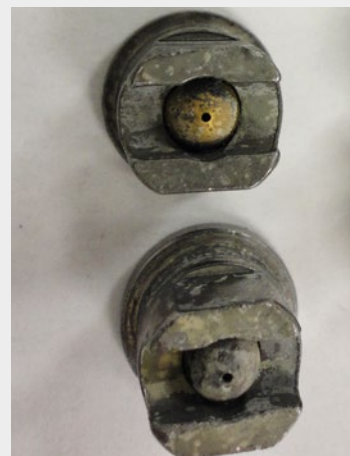
Screen and nozzle from high pressure deburr machine indiana transmission plant

After 3 weeks normal conditions

Before the Vulcan was installed, there would be a **12mm calcium buildup** in the nozzle by this time and they would exchange it with one that had been acid cleaned.

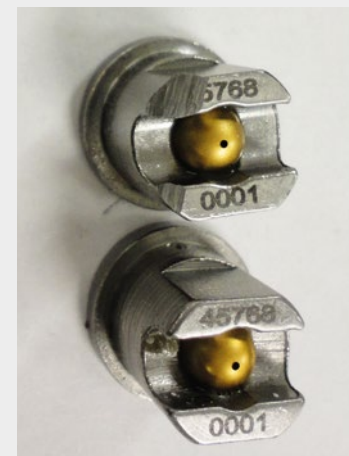
After 3 weeks with Vulcan S25 installed

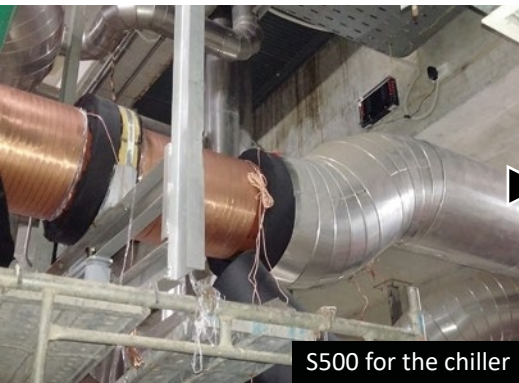
S500 for the chiller

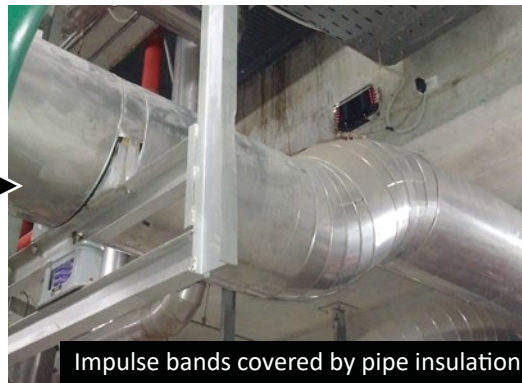
Impulse bands covered by pipe insulation

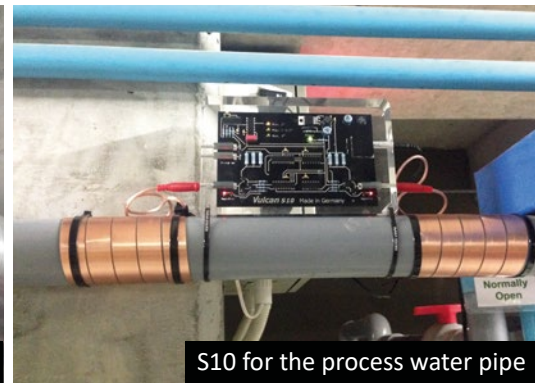
S10 for the process water pipe

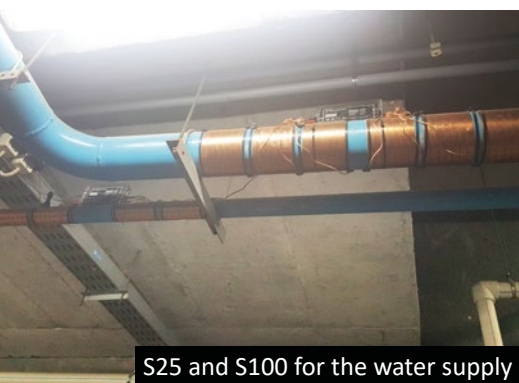
S25 and S100 for the water supply

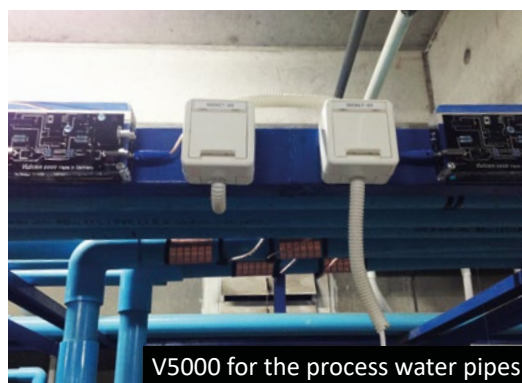
V5000 for the process water pipes

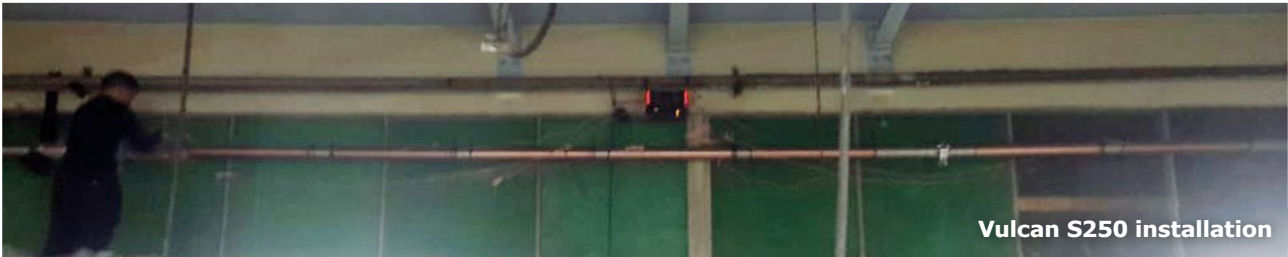
We installed the Vulcan S250 before the hot water return pipe to the exchanger for cooling.

Vulcan S250 installation

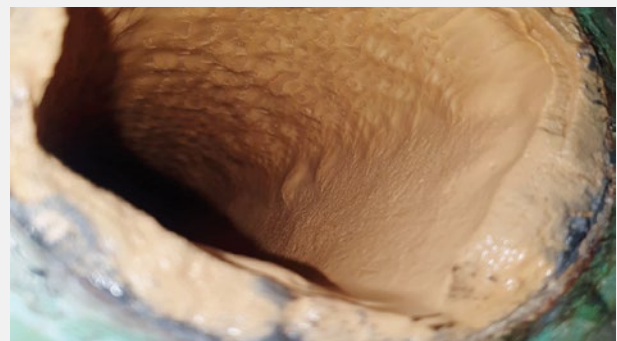
Vulcan results after 4 weeks:

After 4 weeks of installation we checked the pipe chosen for the test and we found results more than expected, we found that the limescale began to clean itself even after 5 days of treatment, given the state of the limescale, it takes more than 1 year for cleaning.

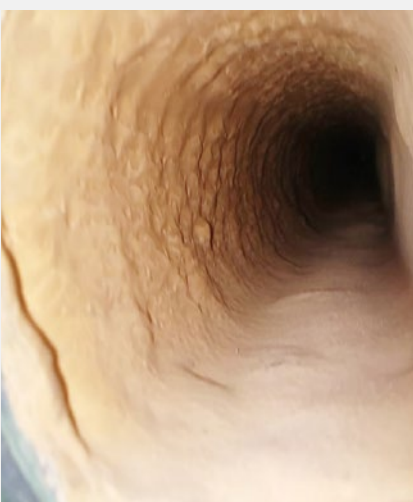
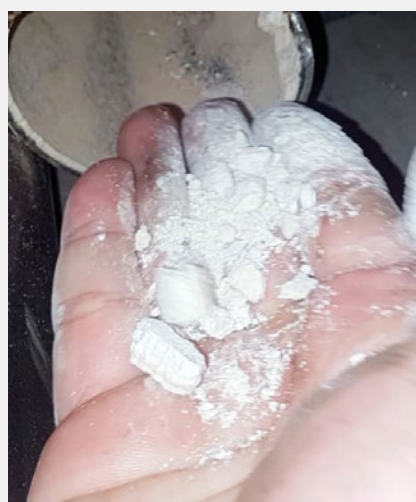
Vulcan results after 7 weeks:

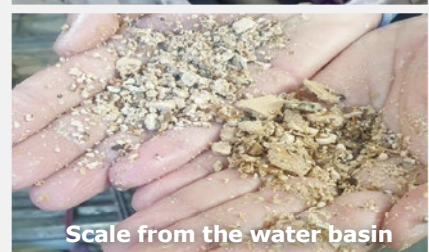
Scale from the water basin

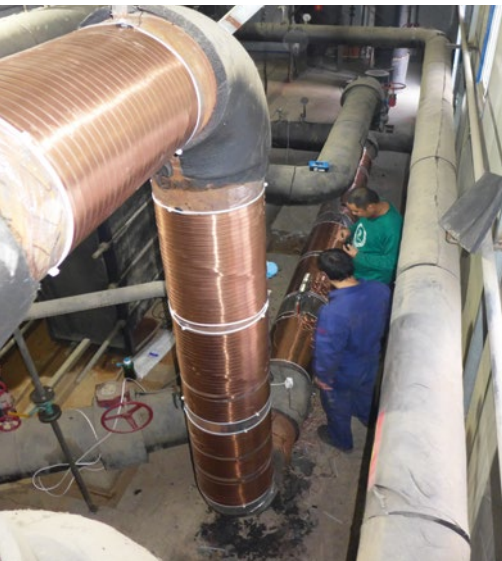
The heat exchange station — Vulcan effect on the plate heat exchanger

After 4 months

Vulcan S500 was installed in the heat exchange station.

The water is underground well water. Vulcan S500 was installed after cleaning the plate heat exchanger. After 4 months, no white scale was seen, only yellow rust was left. Although there were still substances in the plate heat exchanger, they had been softened.

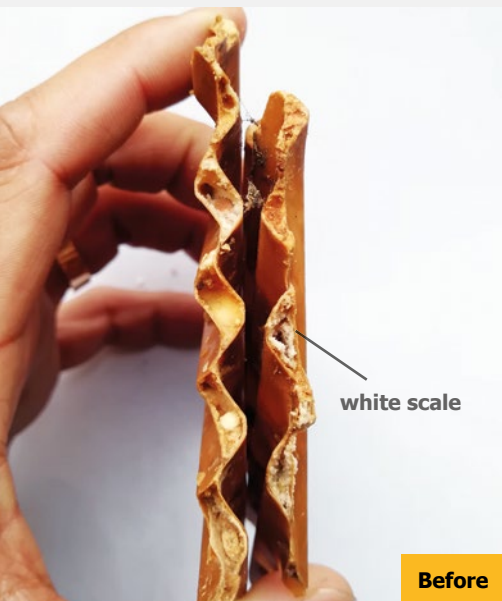
white scale

Before

Without Vulcan S250, the plate heat exchanger was scaled badly, and it was almost blocked every month, must be cleaned manually. The scale was hard, could not be removed by hands.

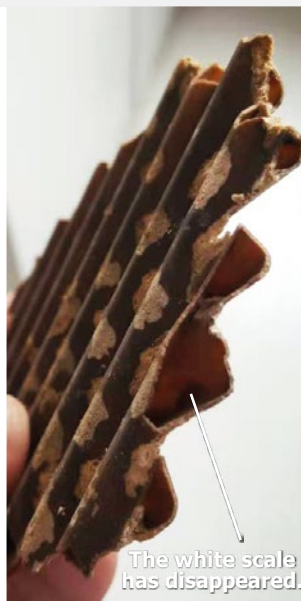
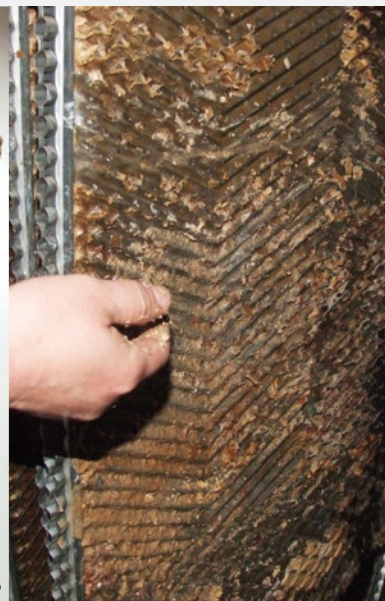
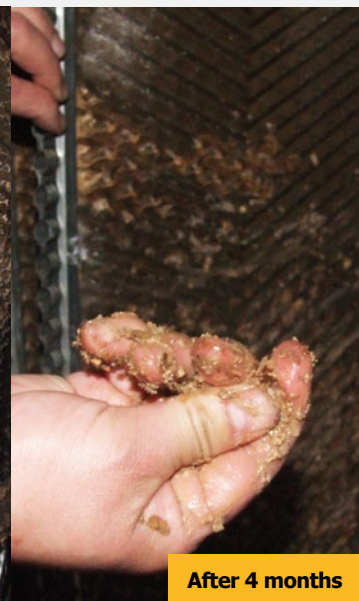
The white scale has disappeared.

After 4 months

We stopped using any additional chemicals to treat the water. After installing Vulcan S250 for 4 months, the effect was very clear. Although there were still substances in the plate heat exchanger, they had been softened and could be easily removed by hands. There are no more white scales, only yellow-brown impurities left.
