The Electronic Anti-Scale System For Cooling Tower Applications

Vulcan – The chemical-free solution

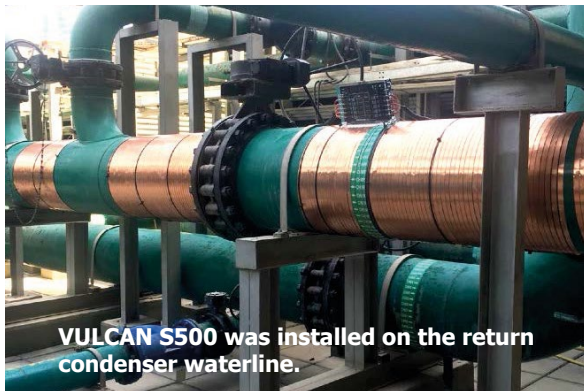
VULCAN S500 was installed on the return condenser waterline.

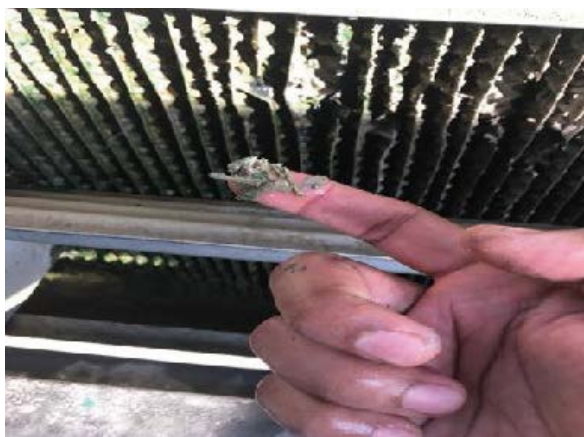
With Vulcan, scale becomes loose.

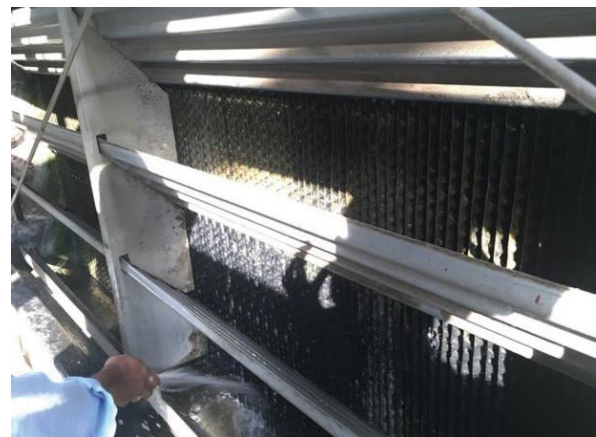
Scale and algae can be removed easily by a water gun.

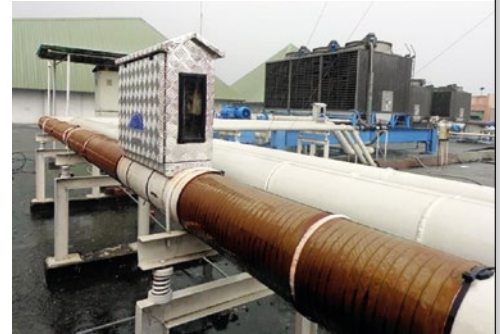
Vulcan S500 was located inside aluminum box and installed on a cooling tower main pipe.

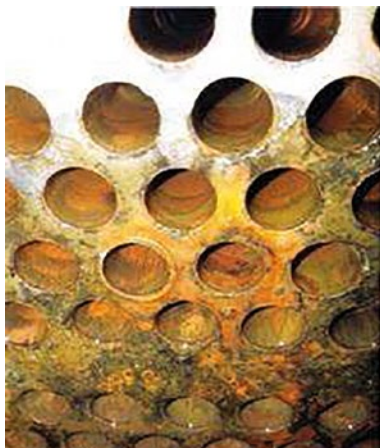
First Inspection: March 4, 2014.

The heat exchanger tube plates were removed to reveal the inside surface of the copper tubes. Since these tubes had recently been manually cleaned, virtually no scale was present, as is on this photo.

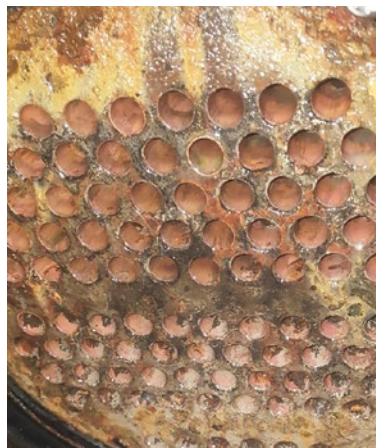
Last inspection: February 12, 2018 at the end of the 4-year trial

The inside surfaces of the copper tubes show zero additional scale formation after 4 years in the test period.

The photographs show that the refrigeration condenser tubes, from the beginning to the end of the trial period, were "as clean as new".

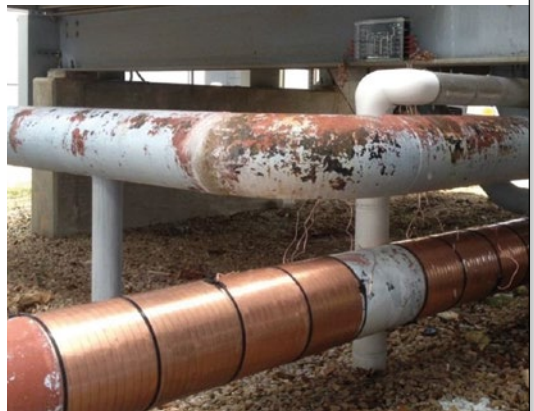
Vulcan S250 installed on a 10 inch diameter line that feeds twin cooling towers (CT-1 and CT-2)

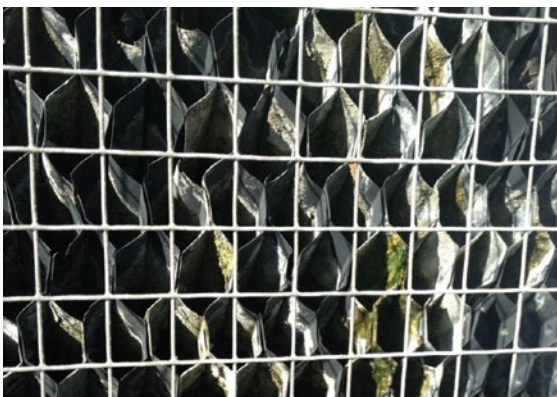
The photo above was taken of CT-1 about **3 weeks** after the Vulcan was installed.

After 3 weeks, the green biofilm had been further reduced and the scale deposits had begun to separate from the flutes in coin-sized flakes.

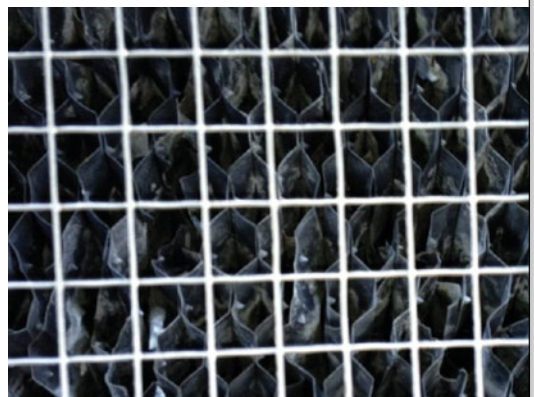
The photo above was taken of CT-1 about **6 weeks** after the Vulcan was installed.

After 1 month, the green biofilm had almost completely disappeared from the surfaces in contact with the Vulcan-treated water. The flakes of scale previously observed had fallen off in most places. The cooling tower flute surface area covered with scale deposits had been decreased by **over 60%**.

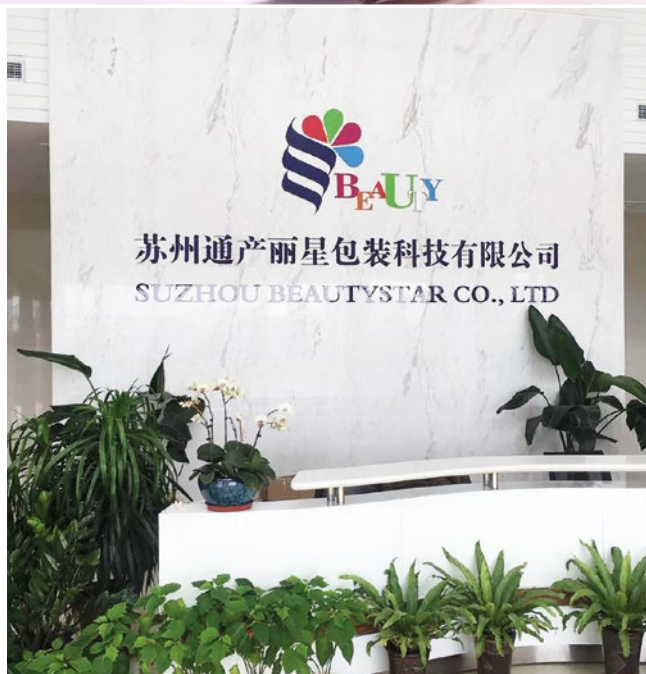
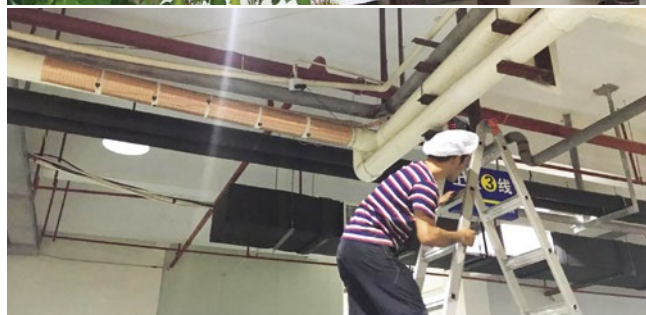
The S150 was installed on the pipe of the dust-free workshop to treat the water for the injection molding machine.

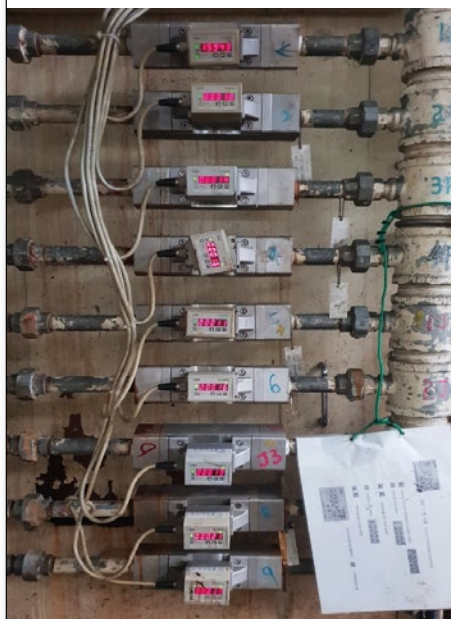
There are 9 secondary small pipes with water meters. These meters were installed to make sure a stable flow rate. If the flow rate goes down, it would cause a problem of the induction hardening machine. Therefore, the pipes had to be cleaned manually every 2-3 months.

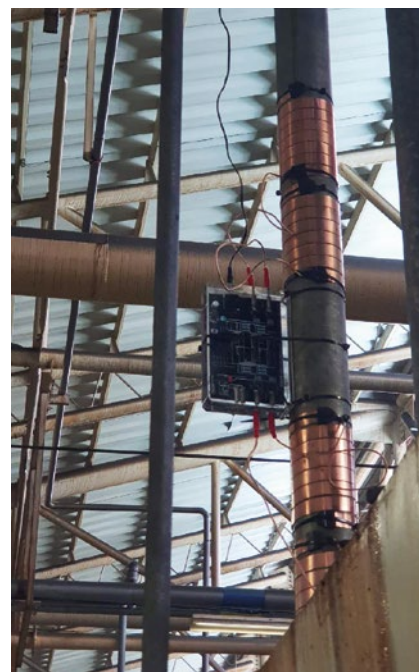
Vulcan S25 was installed around 50 meter before the induction hardening machine.

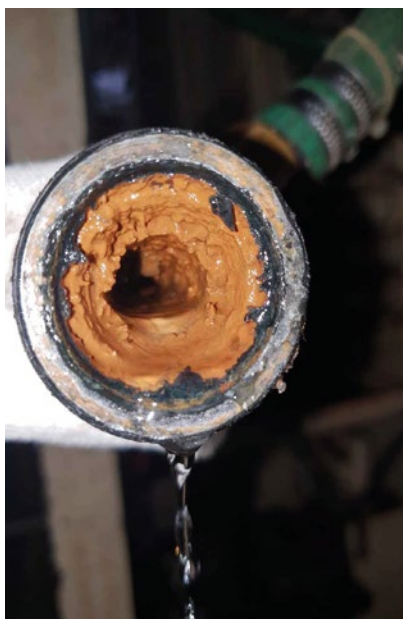
First inspection: May 21, 2018.

Inside of a secondary small pipe, before Vulcan S25 was installed.

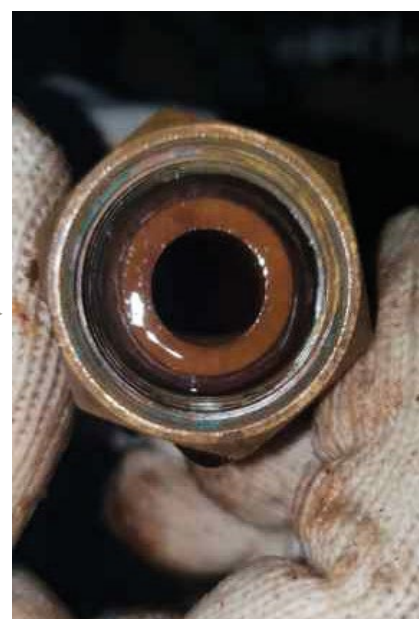
Last inspection: November 21, 2018.

After 6 months with Vulcan treatment: the pipe is free of scale.

2. After Vulcan S25 had been installed for 6 months, the secondary pipes were opened: scale that had been left in piping had disappeared and all 9 secondary pipes had become clean (see photo).

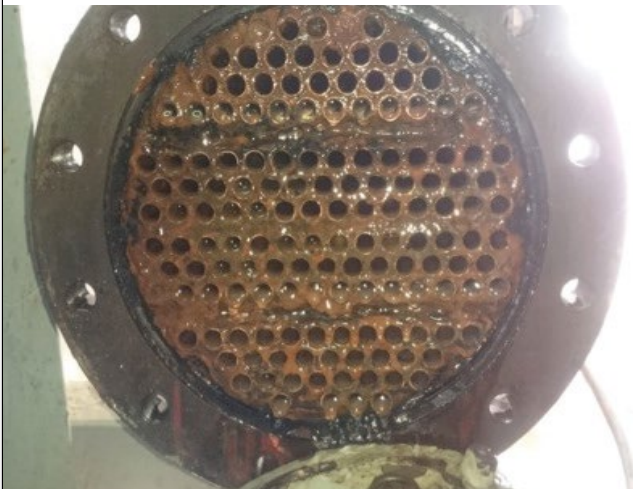
Heat exchanger before Vulcan installation

- scale deposits in oil heat exchanger
- oil temperature >50°C: very high
- to clean every month
- heat exchanger has corrosion
- scale deposits clog the pipe

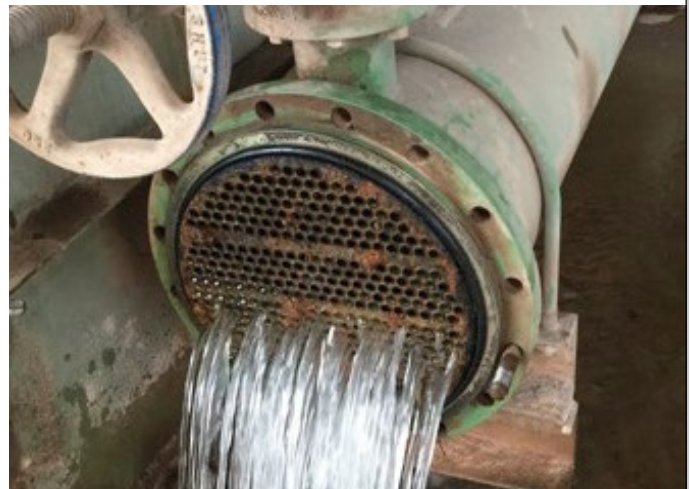
Heat exchanger after 2 months Vulcan installation

- oil heat exchanger is clean
- temperature is stable at 37°C – 40°C
- no need to stop machines to clean anymore
- save 7% energy consumption at grinders

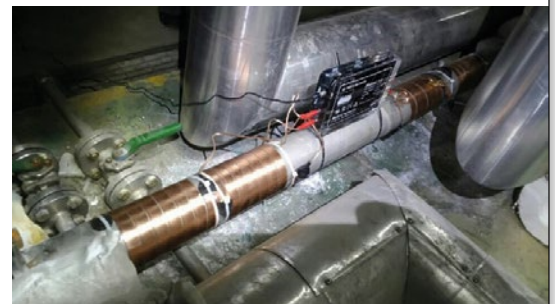
Vulcan S25 installed at Toray Industries

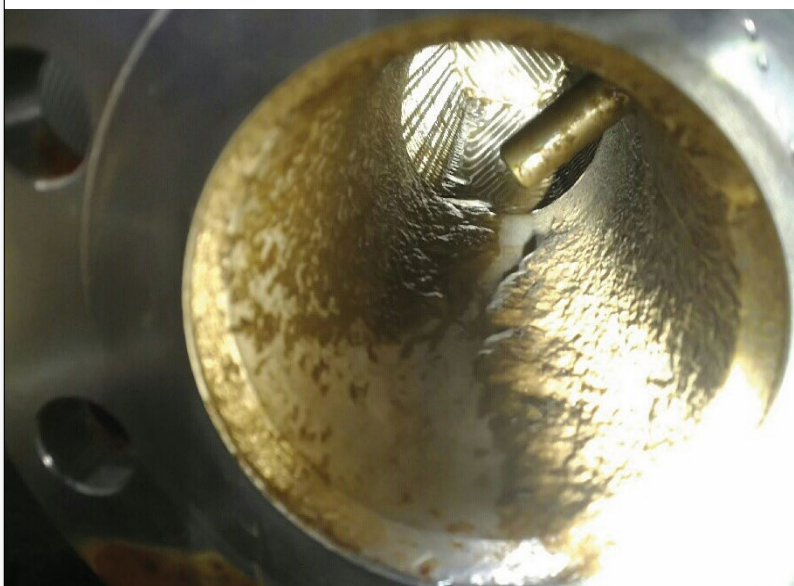
Before – without Vulcan

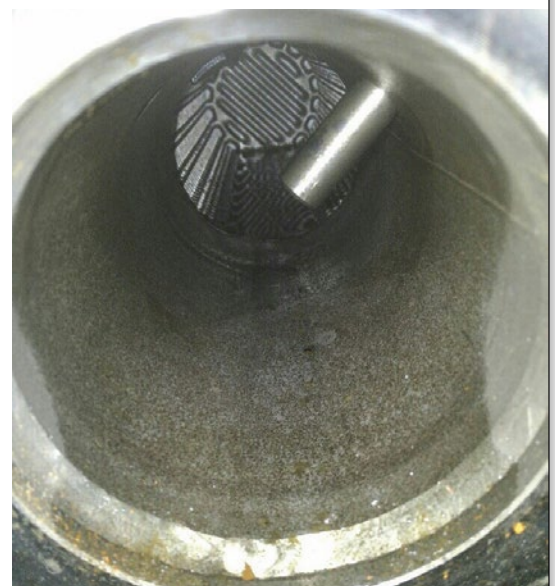
After 3 months – with Vulcan treatment.
Up to now the installed pipeline needed no cleaning.

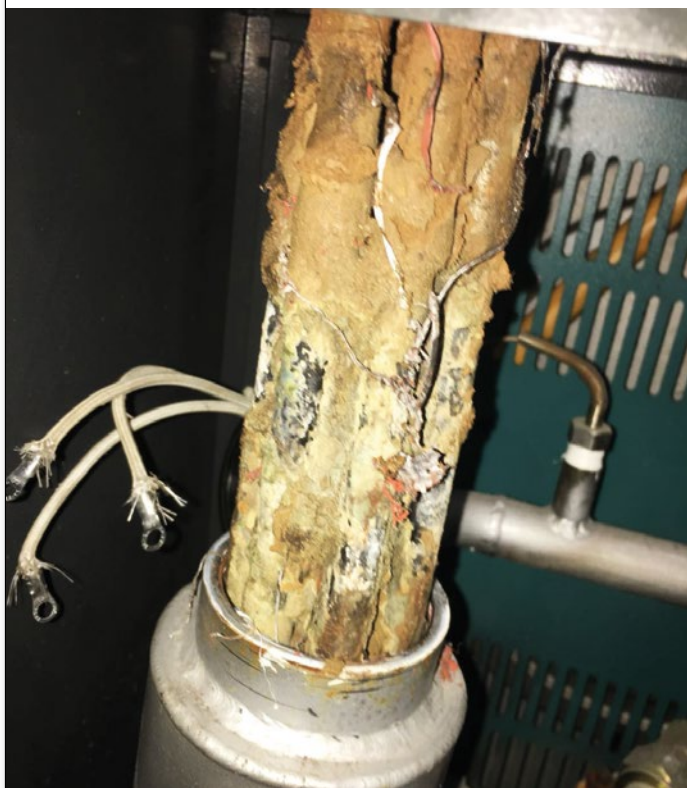
Untreated heat exchanger for 3 years.

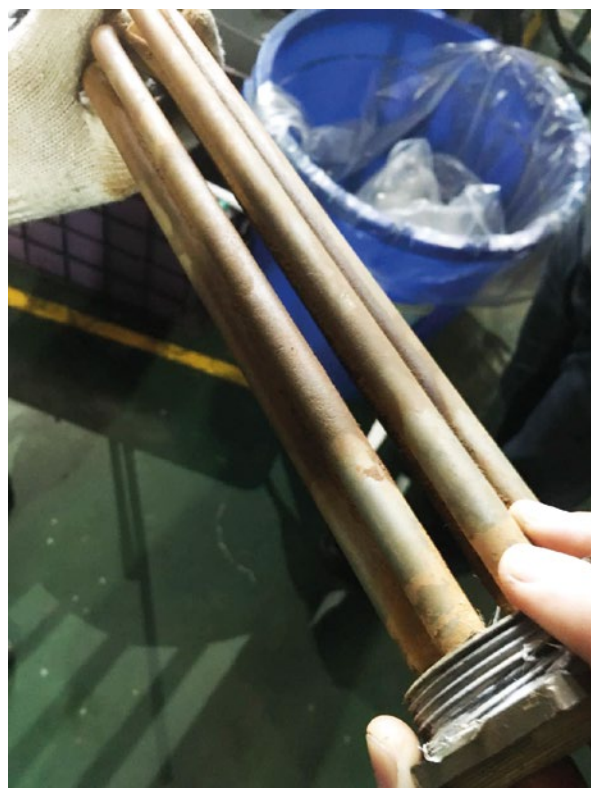
After installing Vulcan for 1.5 years, the scale is gone without extra cleaning.

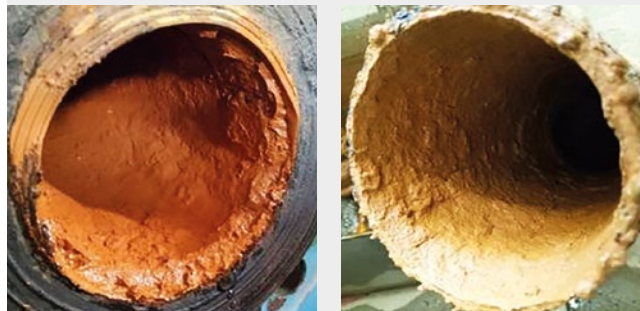
The pipe had been used for 15 years and had a very thick hard scale layer inside. The pipe was not cleaned before Vulcan S10 was installed. The following two photos are the observation points selected before Vulcan installation.

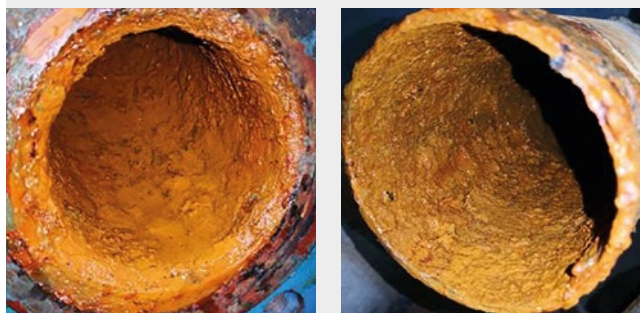
After Vulcan S10 was installed for 4 months

The scales inside the pipe have been gradually reduced, and they do not fall off in blocks, which will not affect the operation of pumps and other equipment. Because of the good results, the customer decides to apply Vulcan in several other cooling systems.

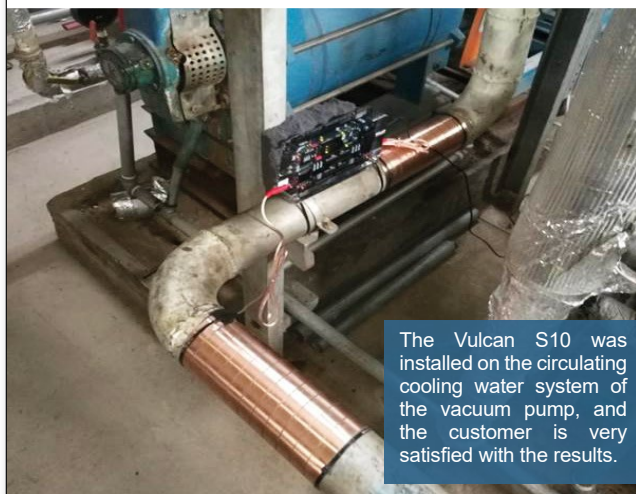
The Vulcan S10 was installed on the circulating cooling water system of the vacuum pump, and the customer is very satisfied with the results.

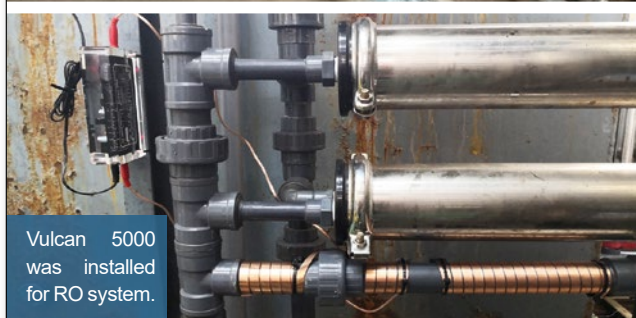
Vulcan 5000 was installed for RO system.

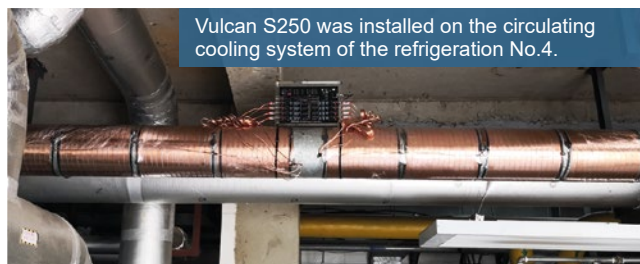
Vulcan S250 was installed on the circulating cooling system of the refrigeration No.4.

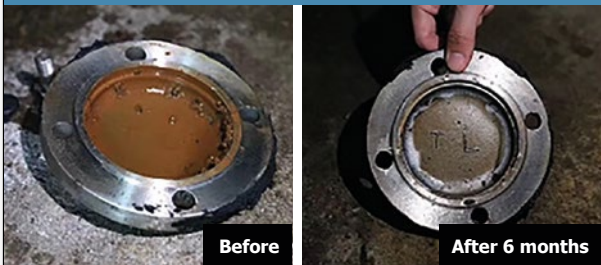
Cooling tower valve: large amount of sludge and scale have been gradually reduced.

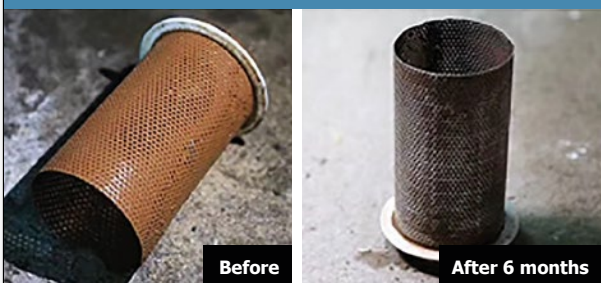
Pipe fittings in the office: they were seriously corroded, now the rust and mud on the inner wall have gradually disappeared.

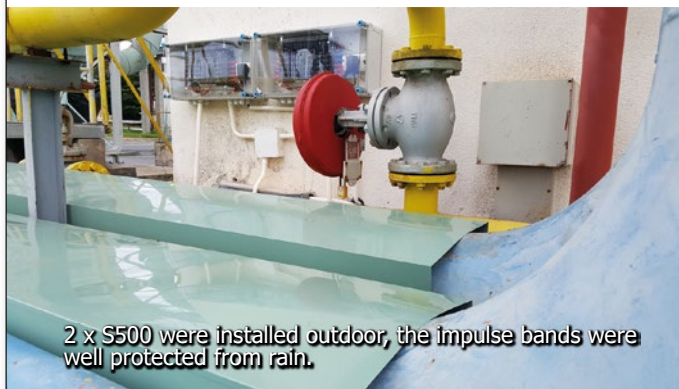
2 x S500 were installed outdoor, the impulse bands were well protected from rain.

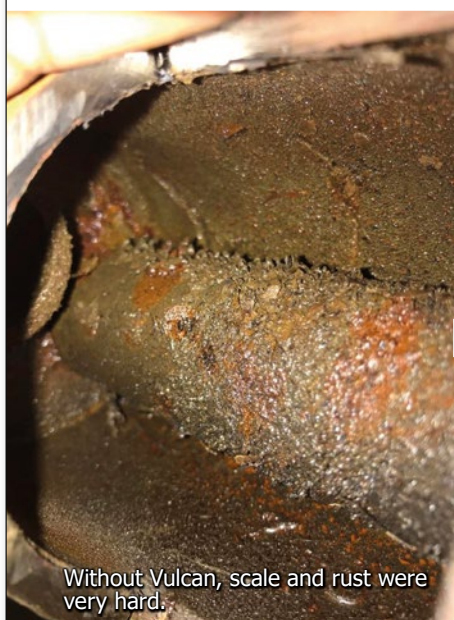
Without Vulcan, scale and rust were very hard.

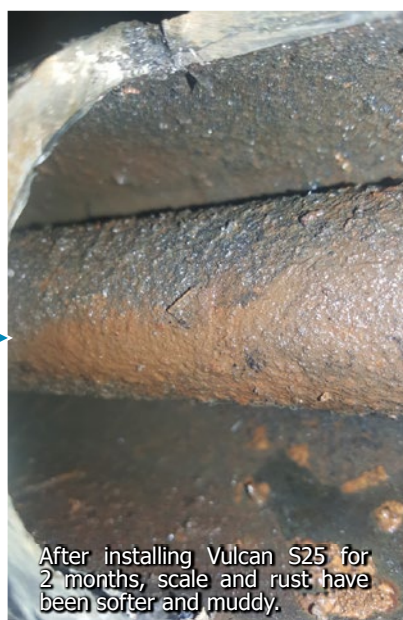
After installing Vulcan S25 for 2 months, scale and rust have been softer and muddy.

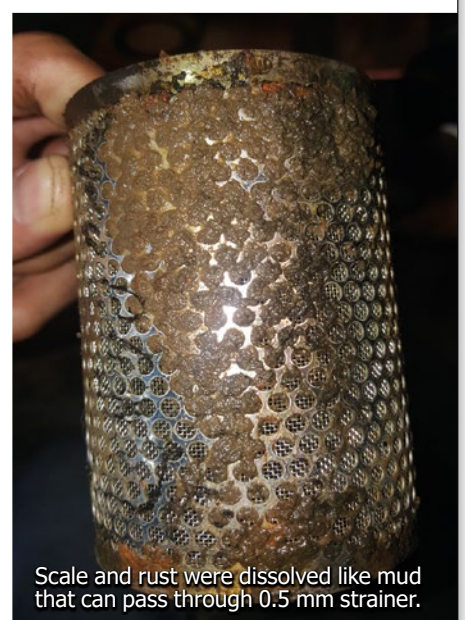
Scale and rust were dissolved like mud that can pass through 0.5 mm strainer.

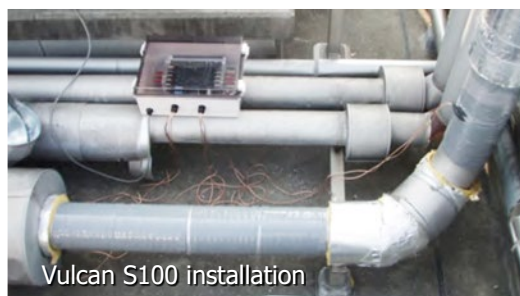
Vulcan S100 installation

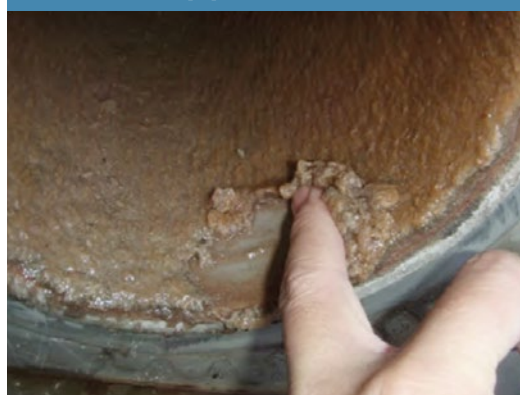
Circulation pipe

Scale becomes soft and can be easily removed with a finger.
