# The Electronic Anti-Scale System For Commercial and Industrial Boilers

# Anti-Scale System

### Typical installation

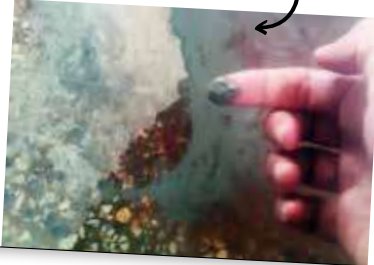
### Vulcan 3000 treats the steam boilers

Before using Vulcan, the steam boilers were non-stopping running for more than 1 year and a small layer of 0.5 mm limescale was found. After 2 months treating with Vulcan, the limescale can be removed easily by a finger.

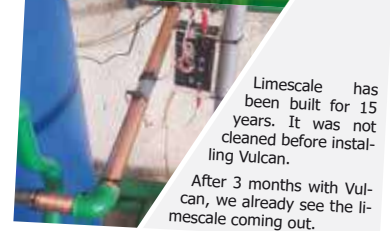
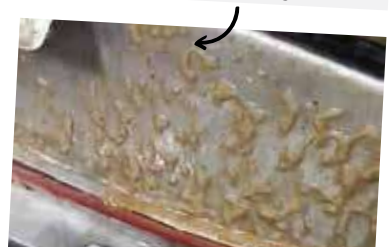
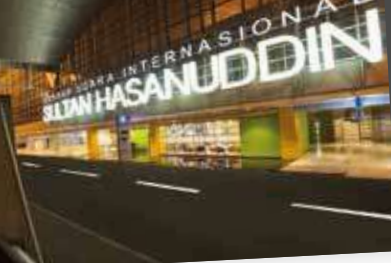
### Vulcan 5000 treats 2 sterilizers

Limescale has been built for 15 years. It was not cleaned before installing Vulcan.  
After 3 months with Vulcan, we already see the limescale coming out.

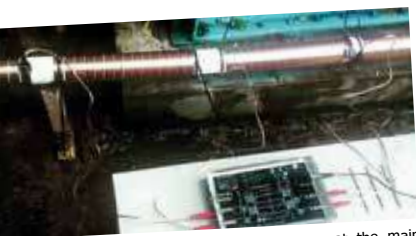
**Picture 1.** Vulcan installation process at the main incoming water line.

Several rooms were monitored before Vulcan was installed and had large amounts of scale chunks on the heating element and at the reservoir sump (see pictures 2 & 3). Vulcan was installed at the main incoming water line to eliminate this problem (see picture 1).

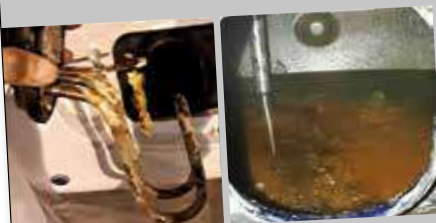
**Pictures 4 & 5.** Three weeks after Vulcan installation, initial scale has been eliminated.

Scale gradually disappeared from the elements and reservoir sump. After 3 months scale is entirely gone from water heater elements and the reservoir sump.

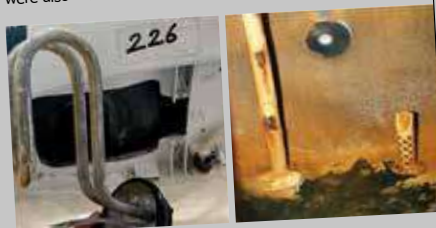
**Pictures 6 & 7.** Twelve weeks after Vulcan installation, no scale at all.

After 3 months, scale deposits had been removed on the heating element and there was no sign of new scale deposits.

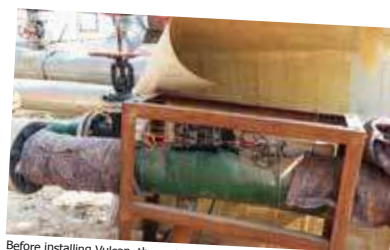
Before installing Vulcan, the rust and pipe insulation were removed, and the impulse bands were wound on the pipe. Then, the outer insulation was put back.

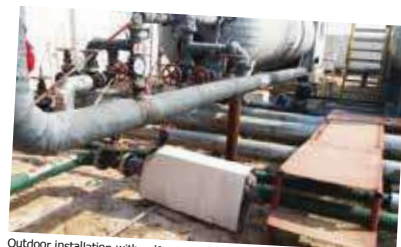
Outdoor installation with self-made cover, to protect the unit from the wind and sun.

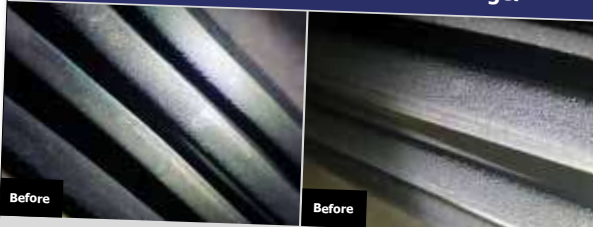
The hard scale between the fins affected the heat transfer efficiency and rusting caused problems with rusty water.

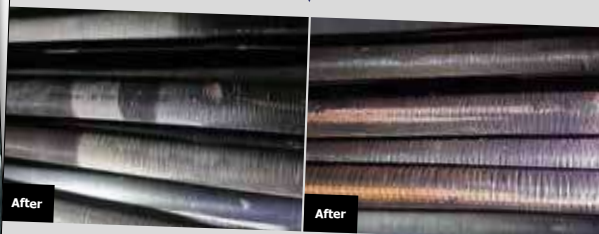
The fins were not cleaned before installing the Vulcan S25. 10 months later, the hard scale between the fins was removed and some areas were clean and even revealed the original colour of the copper tube. Vulcan has improved the water quality and saved energy and manual cleaning costs.

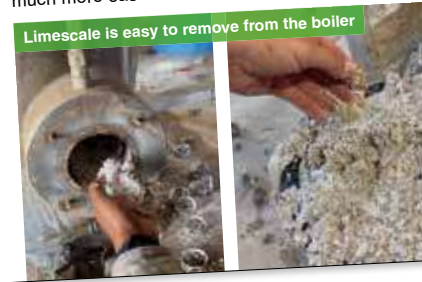
Limescale is easy to remove from the boiler

After installing Vulcan, the boiler was opened after 45 days. „Vulcan works very well.“ We have observed that the limescale became smooth and was easy to remove, which makes maintenance and cleaning much more easier and save a lot of time. „We have less limescale build-up.“

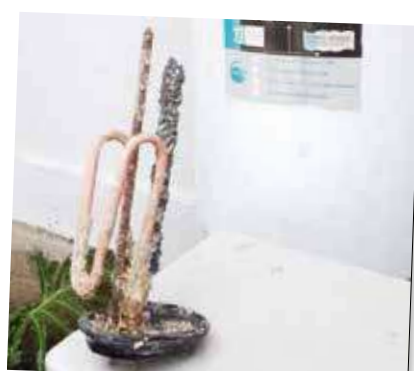
One of the water heaters at a Sea View Bungalow (photo) was opened for inspection and showed much dislodged scale particles at the bottom of the tank, with some easily removed soft scale still present on the element only. This water heater unit had not been scheduled for random inspection since installation of the Vulcan unit at the Resort.

The little remaining scale is soft and easily flushed out since installation of the Vulcan Anti-Scale System.

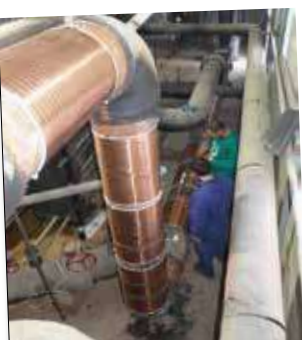
Vulcan S500 was installed in the heat exchange station.

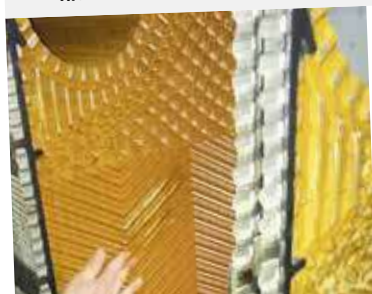
After 4 months

The water is underground well water. Vulcan S500 was installed after cleaning the plate heat exchanger. After 4 months, no white scale was seen, only yellow rust was left. Although there were still substances in the plate heat exchanger, they had been softened.

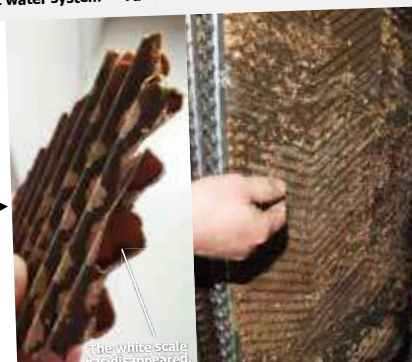
After 4 months

We stopped using any additional chemicals to treat the water. After installing Vulcan S250 for 4 months, the effect was very clear. Although there were still substances in the plate heat exchanger, they had been softened and could be easily removed by hands. There are no more white scales, only yellow-brown impurities left.

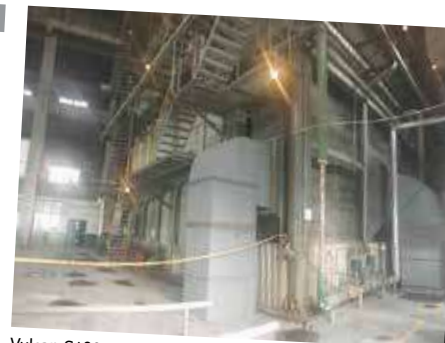
Vulcan S100 was installed on the inlet pipe of the boiler No. 2. After 20 days, the water supply pipe has been depressurized by 0.12 MPa.

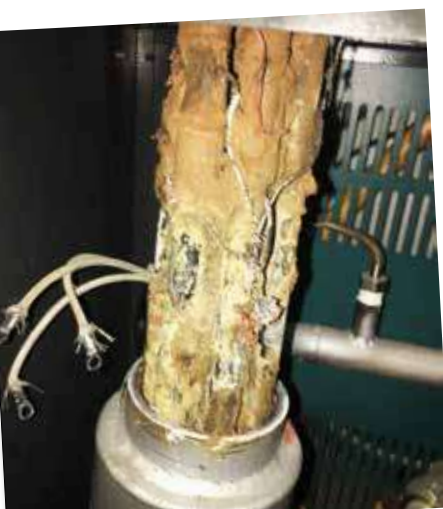
Untreated heat exchanger for 3 years.

One and a half years after Vulcan was installed, we opened the mold temperature controller and checked the heat exchanger.

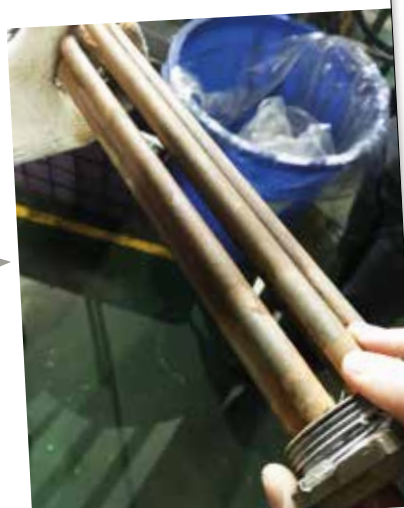
After installing Vulcan for 1.5 years, the scale is gone without extra cleaning.

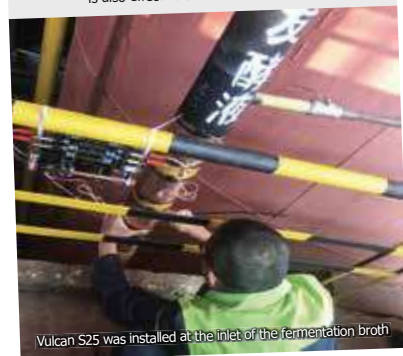
### Installation 1

Location: The inlet of the fermentation broth in the alcohol workshop  
 Pipe size: 80 mm  
 Model: Vulcan S25  
 Result: After 2 months, the scale in the fermenter has been significantly reduced, it shows that Vulcan is also effective at the fermentation broth.

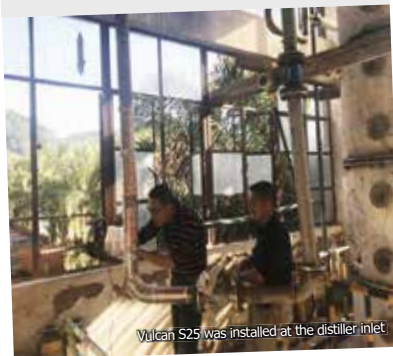
### Installation 2

Location: The distiller inlet in the alcohol workshop  
 Pipe size: 80 mm  
 Model: Vulcan S25  
 Result: After 2 months, the scale in the distillation tower has been significantly reduced.

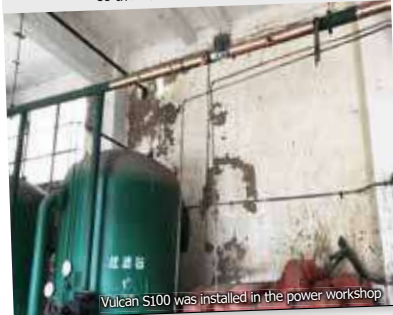
### Installation 3

Location: Power workshop of the sugar factory  
 Pipe size: 100 mm  
 Water flow: 80 m³/h  
 Model: S100  
 Purpose: To solve the scaling problems of boilers  
 Result: After 2 months, the scales in the salt tank of the water softener have been reduced, and the scales from the pipe also began to fall off, so the water softener was turned off.

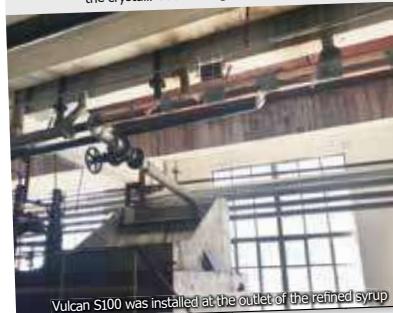
### Installation 4

Location: The outlet of the refined syrup, the material temperature is 60 °C  
 Pipe size: 150 mm  
 Model: S100  
 Purpose: To solve the scaling problems of the refined syrup processing equipment  
 Result: The scaling problems of the syrup processing equipment and the filter have been solved, and the crystallization of sugar has not been affected.

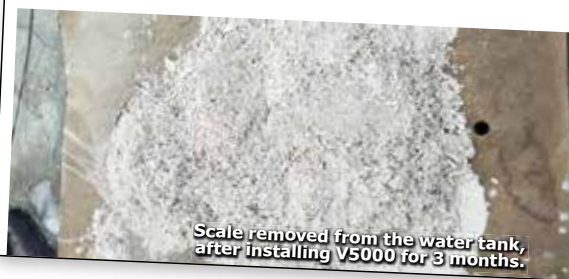
3. After 3 months of installation, we cleaned the hot water tank, and found a large amount of scales were drained out. The photo below is the scales removed from the water tank. Also, the heat transfer efficiency of the solar system has been significantly improved.

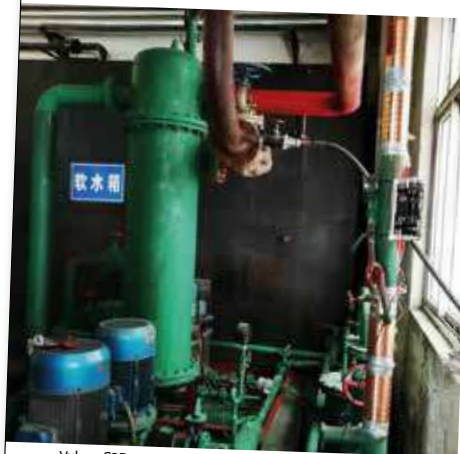
Vulcan S25 was installed on the main water pipe in the boiler room.

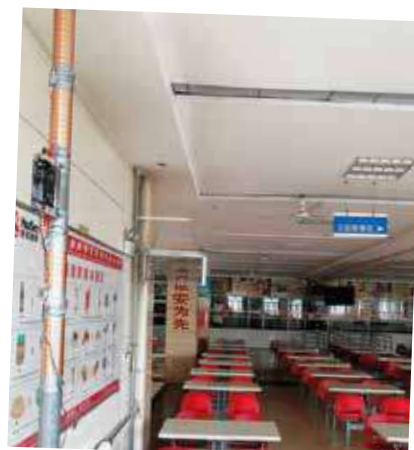
Vulcan S25 was installed to solve the scaling problems for the canteen.
